ROYAL AIRCRAFT ESTABLISHMENT

TECHNICAL REPORT No. 65148

BIRD IMPACT TESTS OF VULCAN AIRCRAFT WINDSCREENS

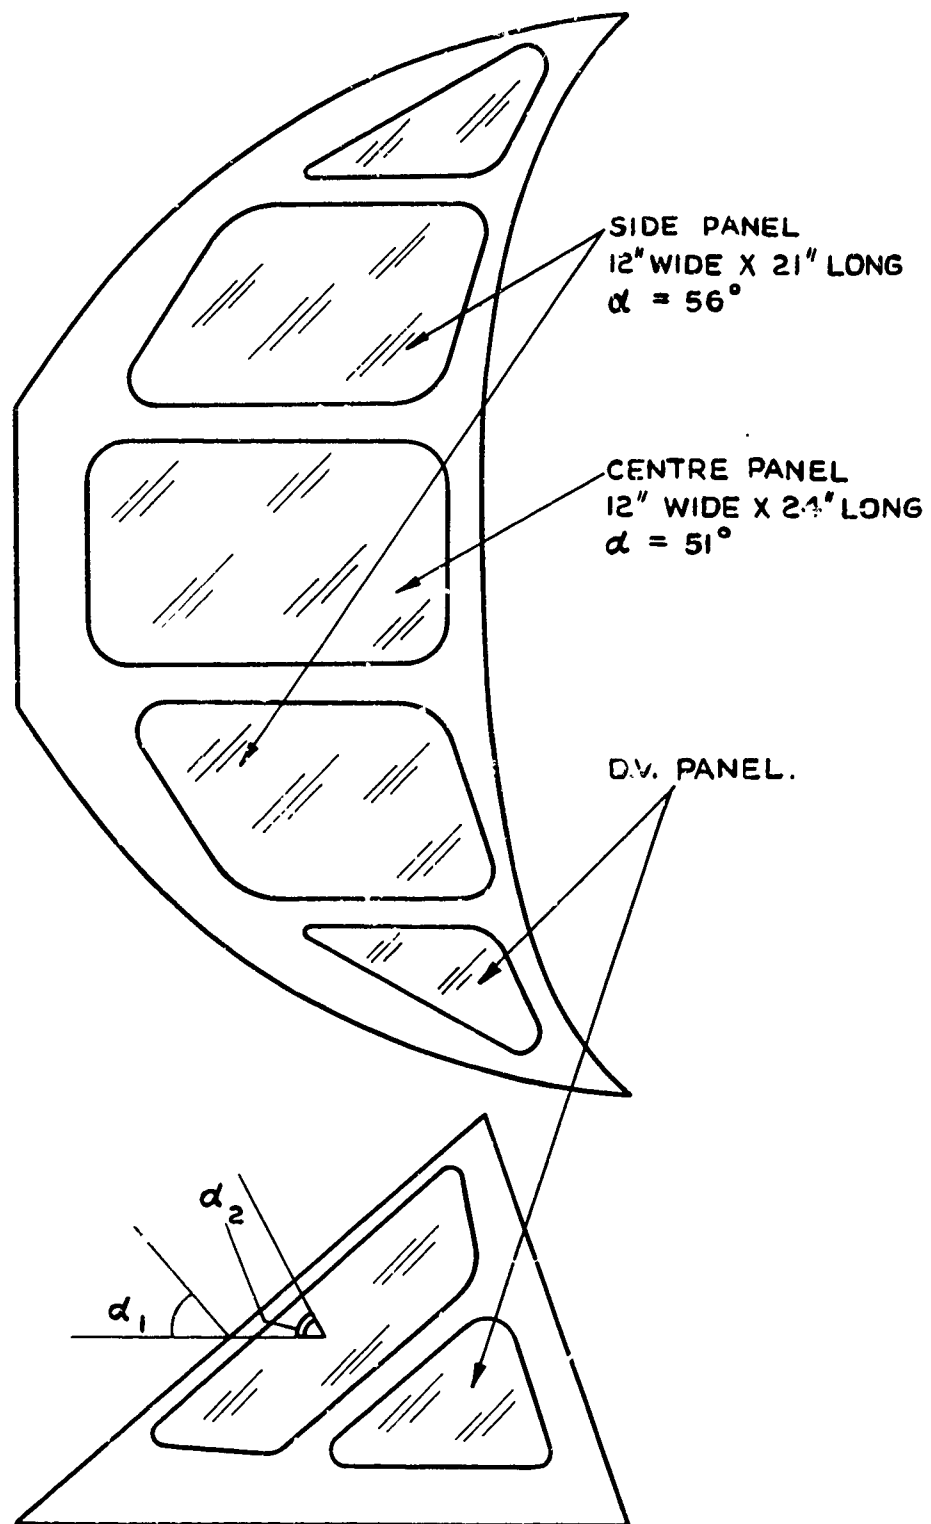
FIG.1 VULCAN WINDSCREEN MOUNTING DIAGRAMMATIC

Similar windscreen mounting frames are fitted to B Mk.1 and B Mk.2 Vulcan aircraft, but the windscreen panels are not of the same construction in both Marks of aircraft. As shown diagrammatically in Fig.1 and in Fig.2 there is a total of 5 transparent panels in the windscreen assembly of which 2, the lower rear panels, are small D.V. windows which were not included in the bird resistance investigation. The three main transparencies consist of a flat centre panel approximately 12" wide x 24" long at an impact angle of 51° (the angle between the line of flight and the normal to the windscreen), and two flat side panels, one ahead of each pilot, approximately 12" wide x 21" long at an impact angle of 56° .

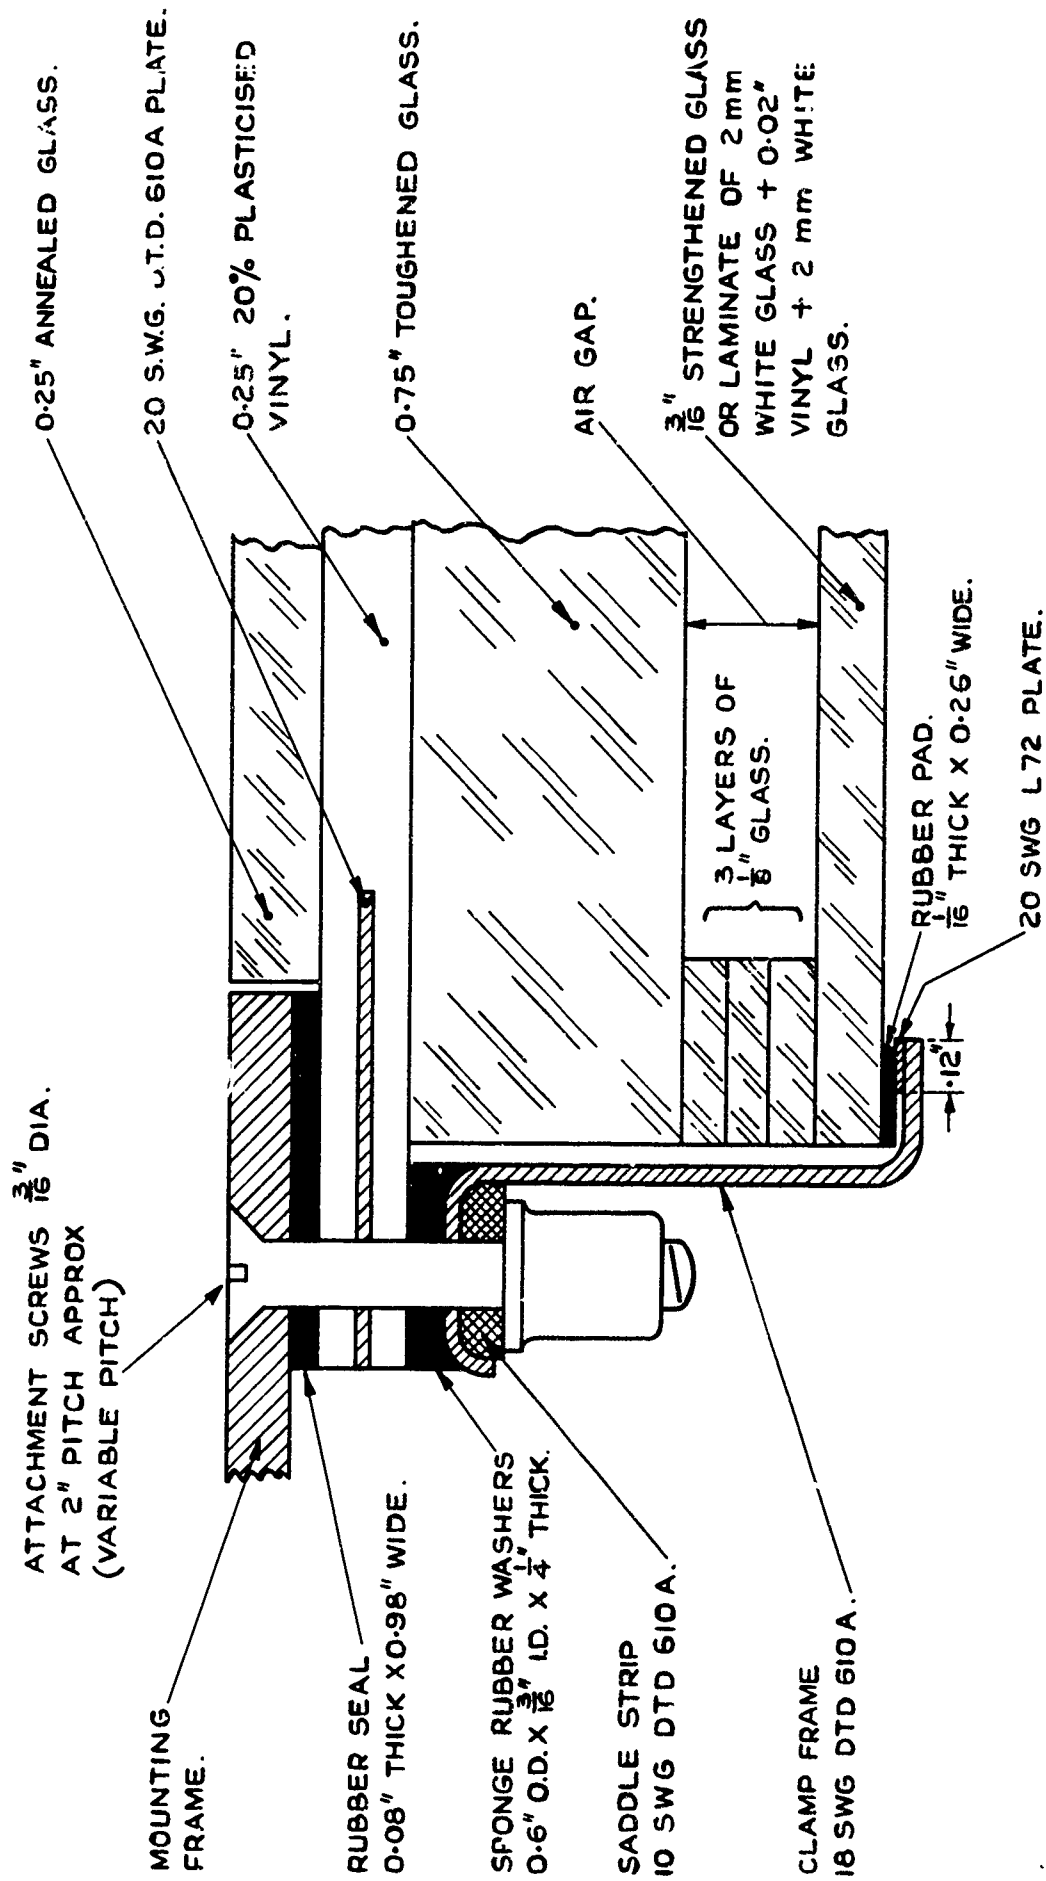
FIG.3 ATTACHMENT FITTING AND PANEL DETAILS DRY AIR SANDWICH TYPE SCREENS

In the case of the B Mk.1 Vulcan the centre and side panels are of similar construction and method of edge attachment to the windscreen frame. The panels are of dry air sandwich construction and are shown in detail in Fig.3. The two main strength members are the 0.25" thick layer of poly-vinyl-butyrac (P.V.B.) and the 0.75" thick layer of sweep toughened glass. The innermost layer of the panel can be either a single pane of 3/16" strengthened glass or a sandwich laminate of 2 mm glass and 0.02" P.V.B.: samples of both types were tested

in the investigation. The use of dry air sandwich construction is detrimental to the bird impact resistance of the P.V.B. layer of the windscreen. The high thermal resistance of the air gap which results in the inner surface of the screen having a temperature not greatly different from that of the cabin, and thereby achieving freedom from misting, also results in the layer of P.V.B. attaining a temperature that is not greatly different from the indicated outside air temperature (O.A.T.). During flight with low O.A.T. the temperature of the P.V.B. layer is therefore well below the optimum ($45-50^{\circ}\text{C}$) for the bird impact resistance.

The resistance of the toughened glass layer is more or less in agreement with the theoretical value i.e. crazing of the main pane occurred at approximately the theoretical penetration speed for the toughened glass layer. This implies that the support of the main glass pane was better in the case of the gold film screen than in that of the dry air sandwich screens. Comparison of Figs.3 and 4 shows that this appears to be so.

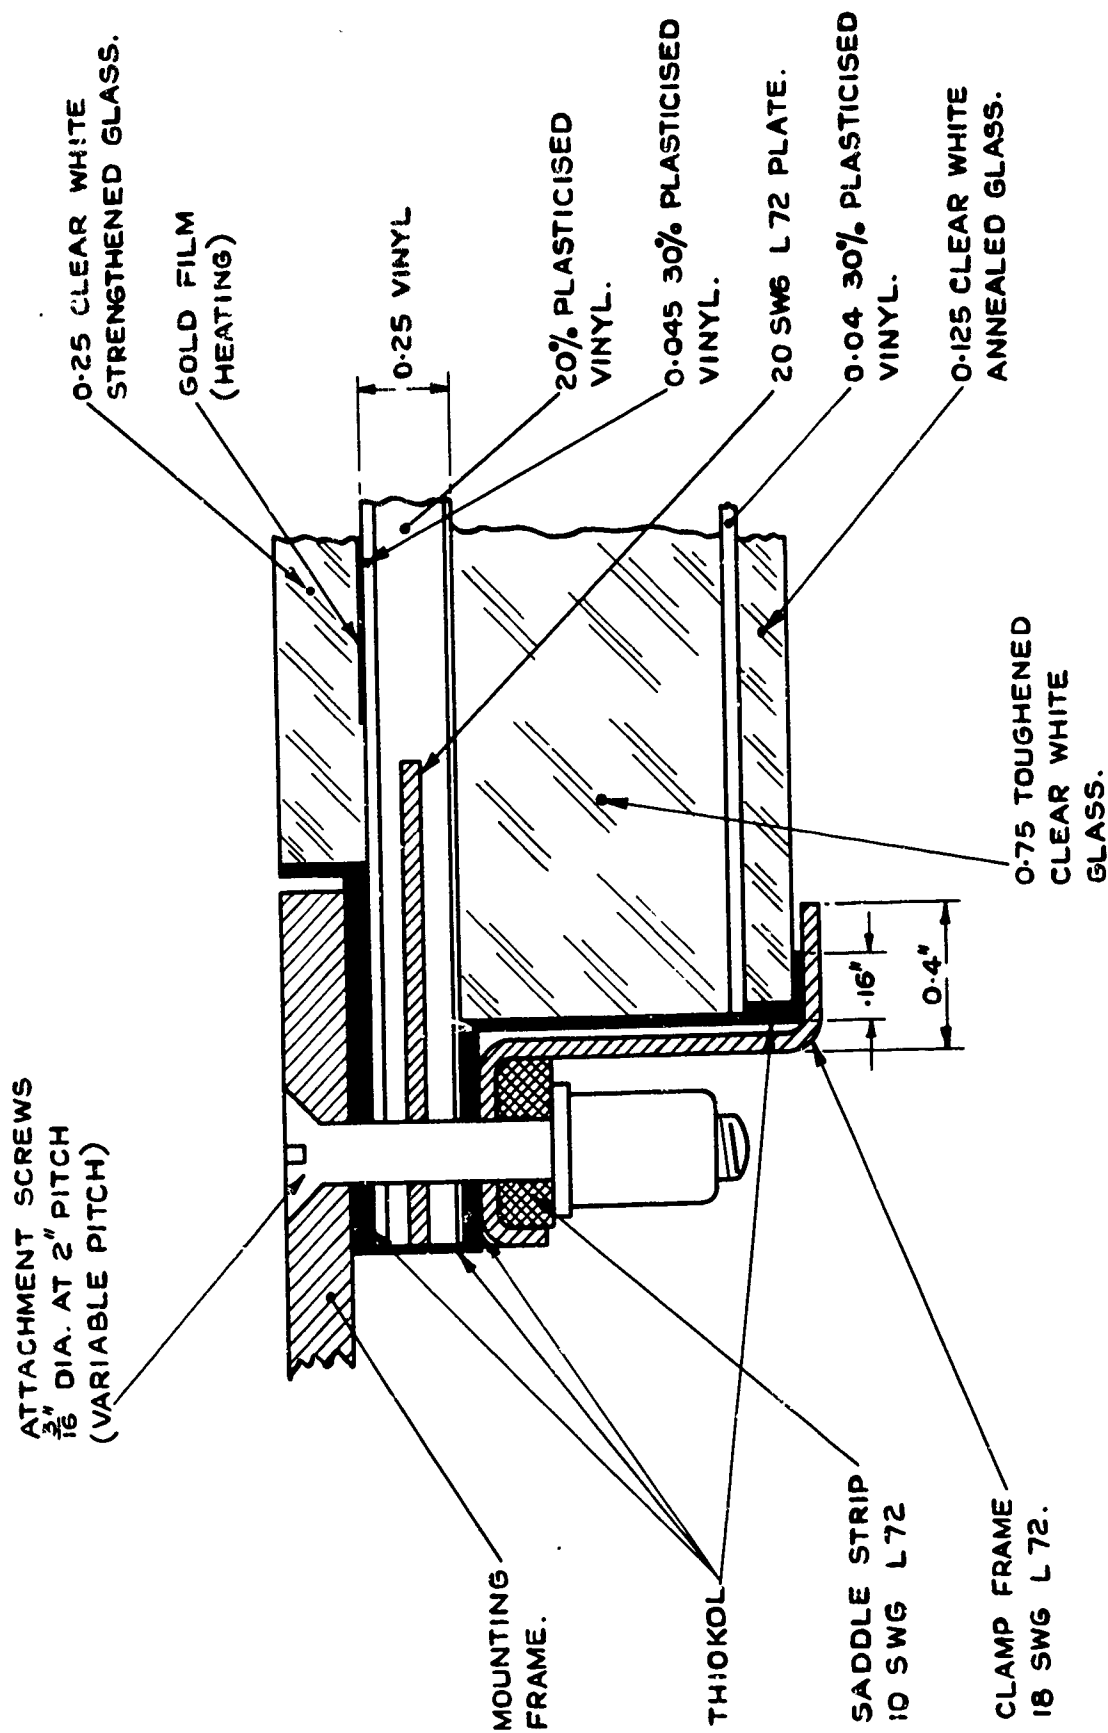
Fig. 4

FIG. 4 ATTACHMENT FITTING AND PANEL DETAILS GOLD FILM TYPE SCREENS

The centre and side panels of the B Mk.2 Vulcan are of gold film type and have construction details and mounting attachment as shown in Fig.4. The main strength members are the 0.25" layer of P.V.B. and the 0.75" layer of toughened glass. The use of the gold film heater for demisting results in the temperature of the P.V.B. layer being maintained at 50°C which is within the optimum range of temperature for P.V.B. bird impact resistance. The gold film heating layer for the side panels is divided into three zones each fed from a separate phase of a 3 phase A.C. supply. Due to the shape of the panel the three zones are not equal in area and one is shorter than the other two and requires a lower supply voltage (see para. 3.2).

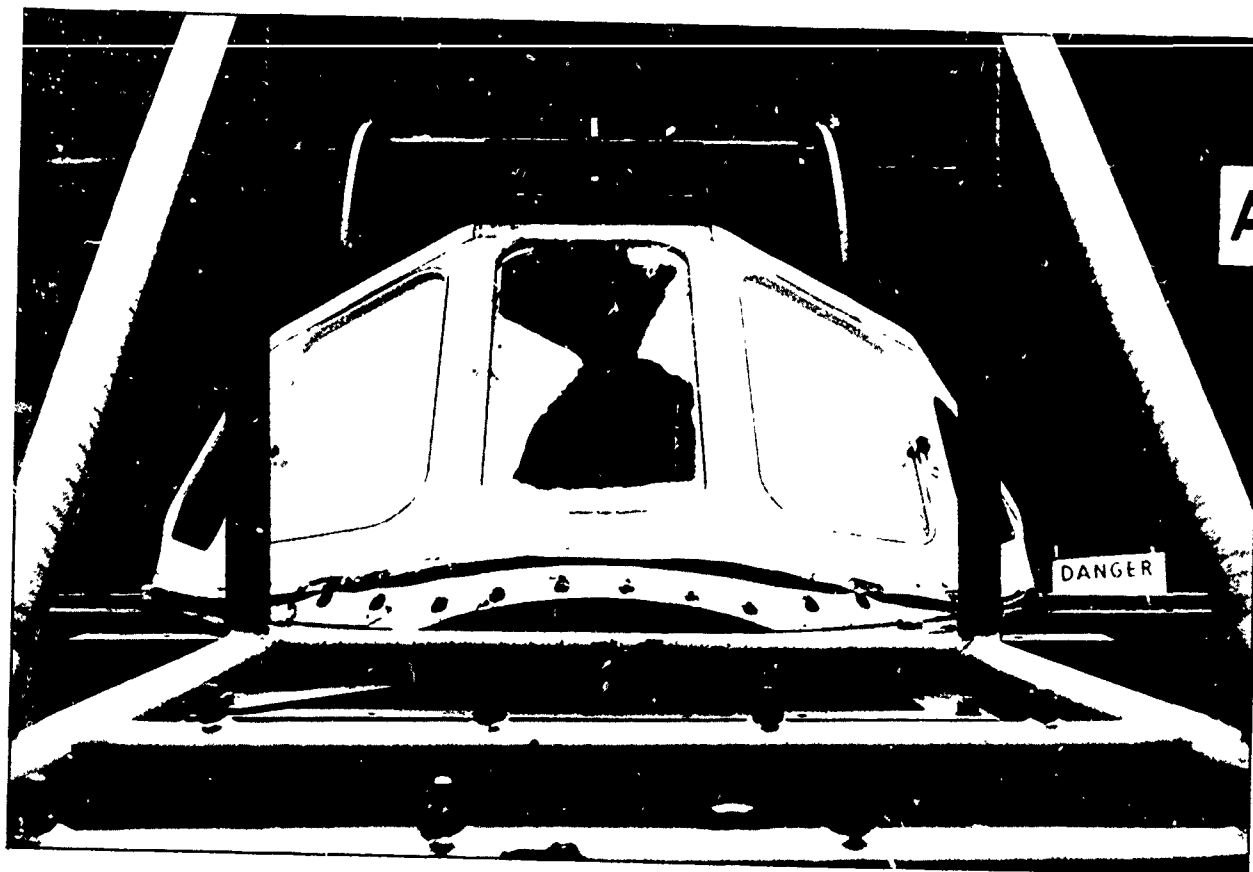
Fig.5 Typical of complete failure

Impact of 4lb bird at 258kt on dry air sandwich centre screen at 5°C

(a) Complete failure: the projectile penetrated the panel and large fragments together with severe spalling were scattered rearwards. Fig.5 typifies this damage. (Test 1 on dry air sandwich panel)

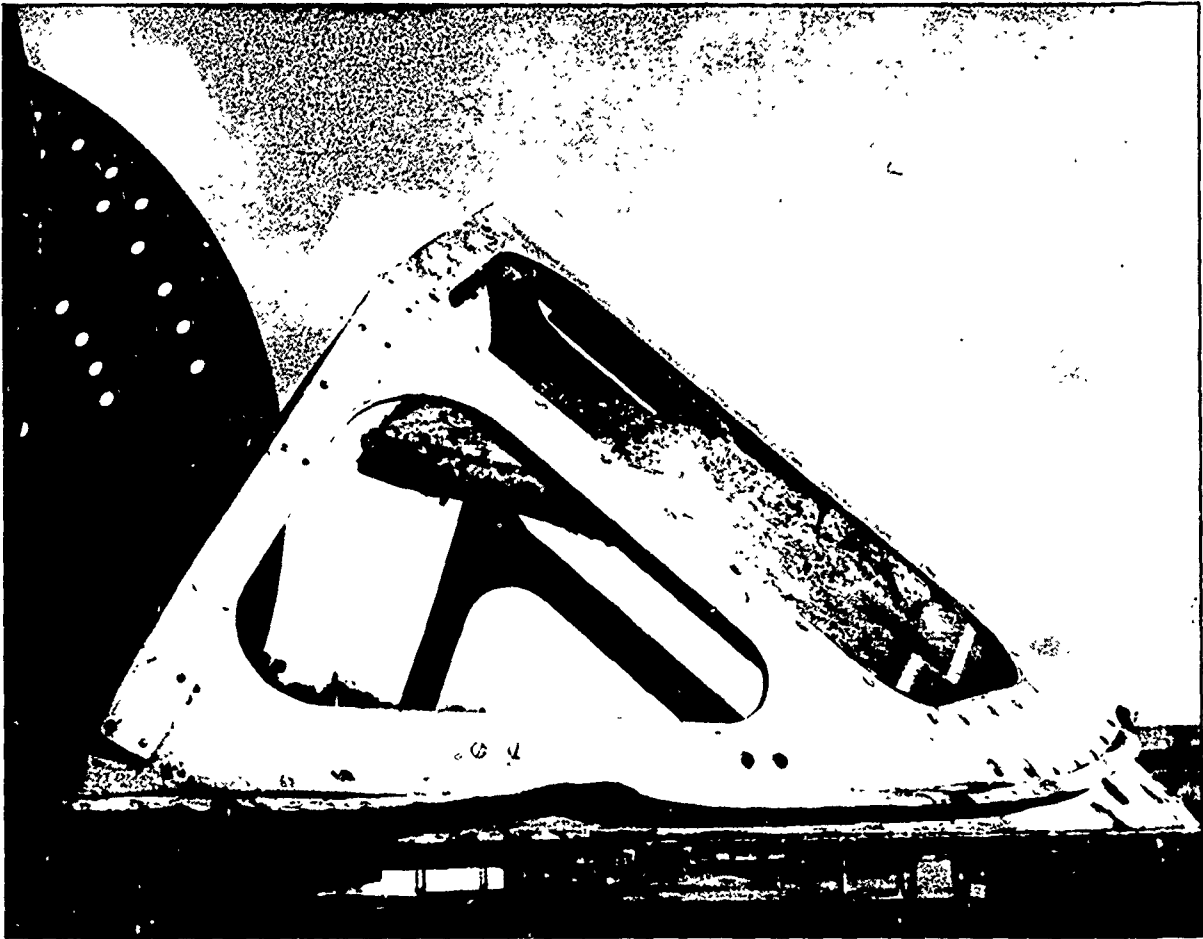
Impact of 4lb bird at 269kt on heated (+ 50°C) side screen in OAT—9°C

Fig.6 Typical of severe damage

(b) Severe damage: the panel was penetrated and considerable spalling was observed. Fig.6 typifies this damage. (Test 3 on gold film panel.)

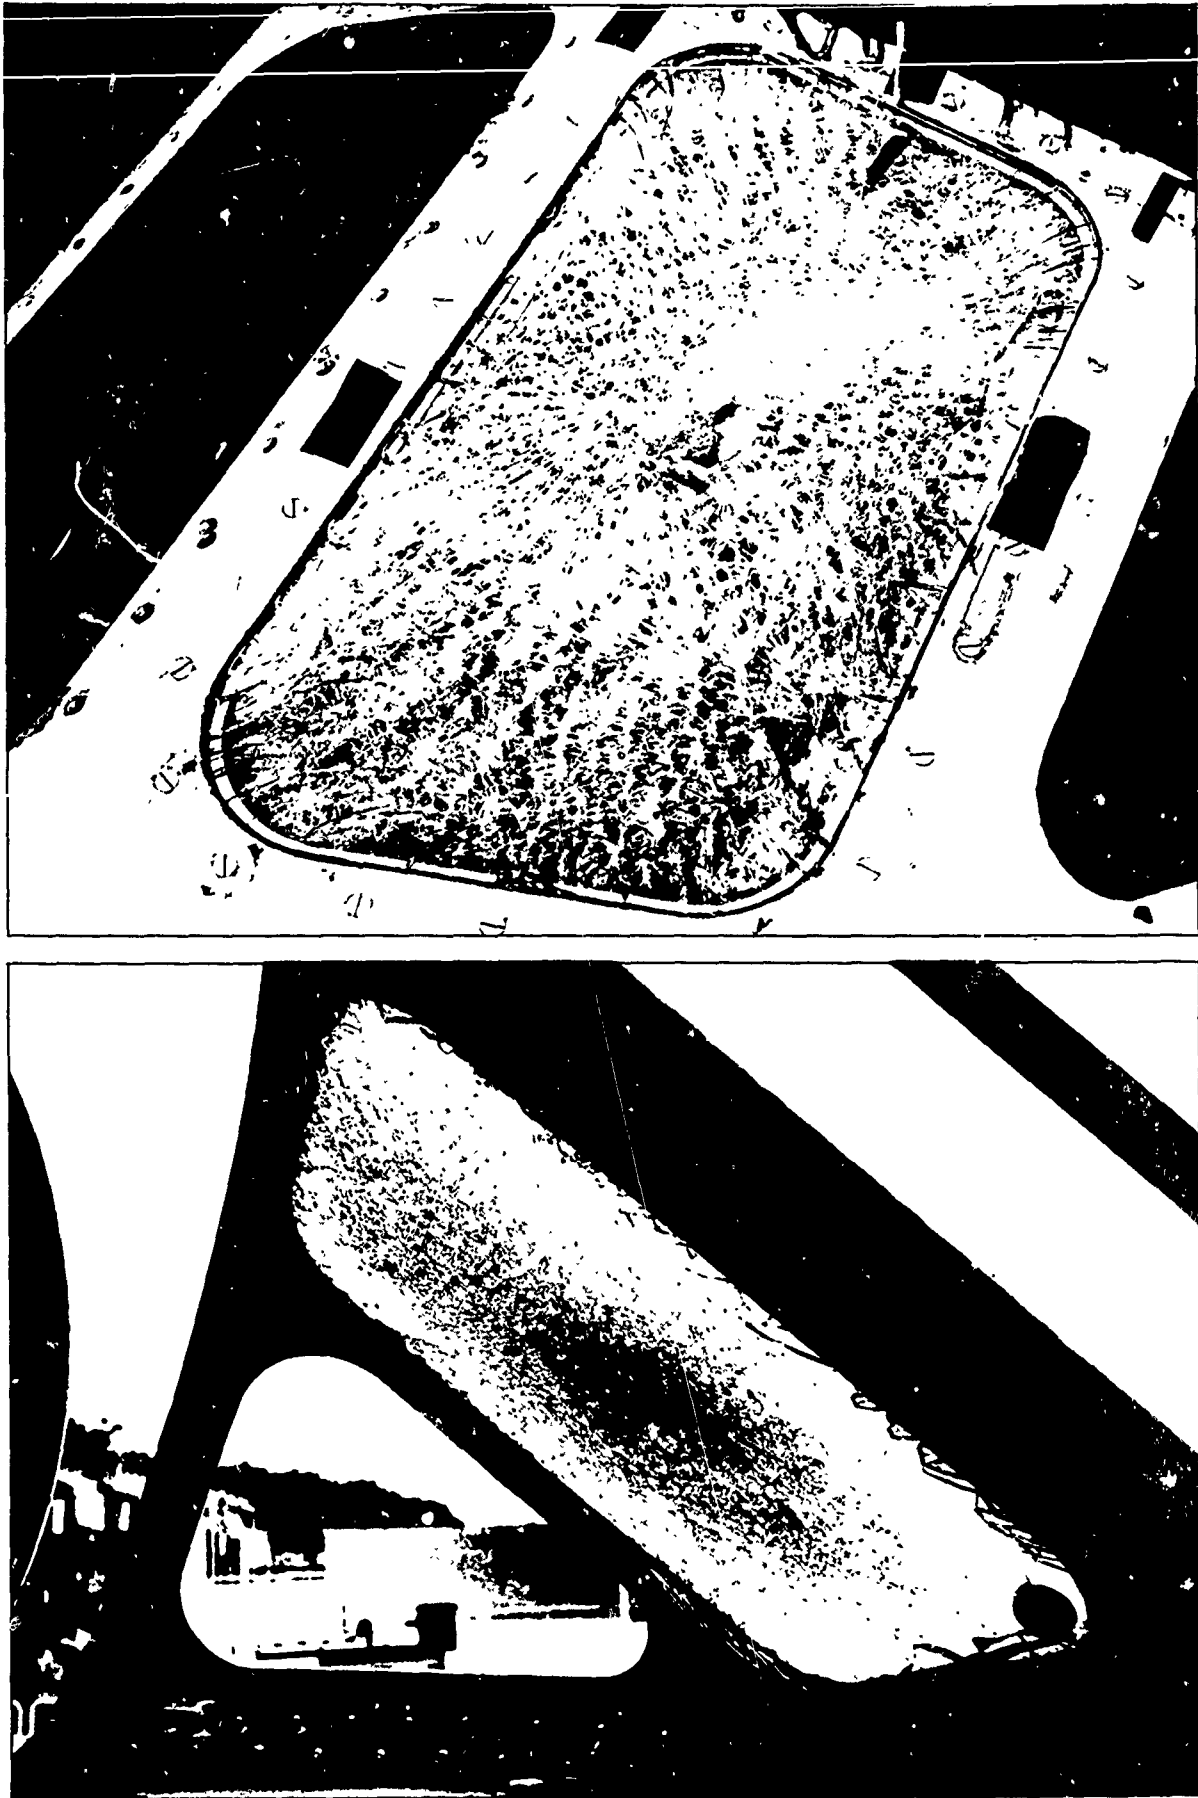
Fig.7 Typical of no penetration (Upper limit)

Impact of 4lb bird at 177kt on dry air sandwich side screen at -1°C

(c) No penetration: the panel was not penetrated. At the upper end of this category limited spalling of the inner pane was observed of which Fig.7 (D.A.S. Test 6) is typical. At the lower end the damage was slight and no spalling resulted, Fig.8 (G.F. Test 4).

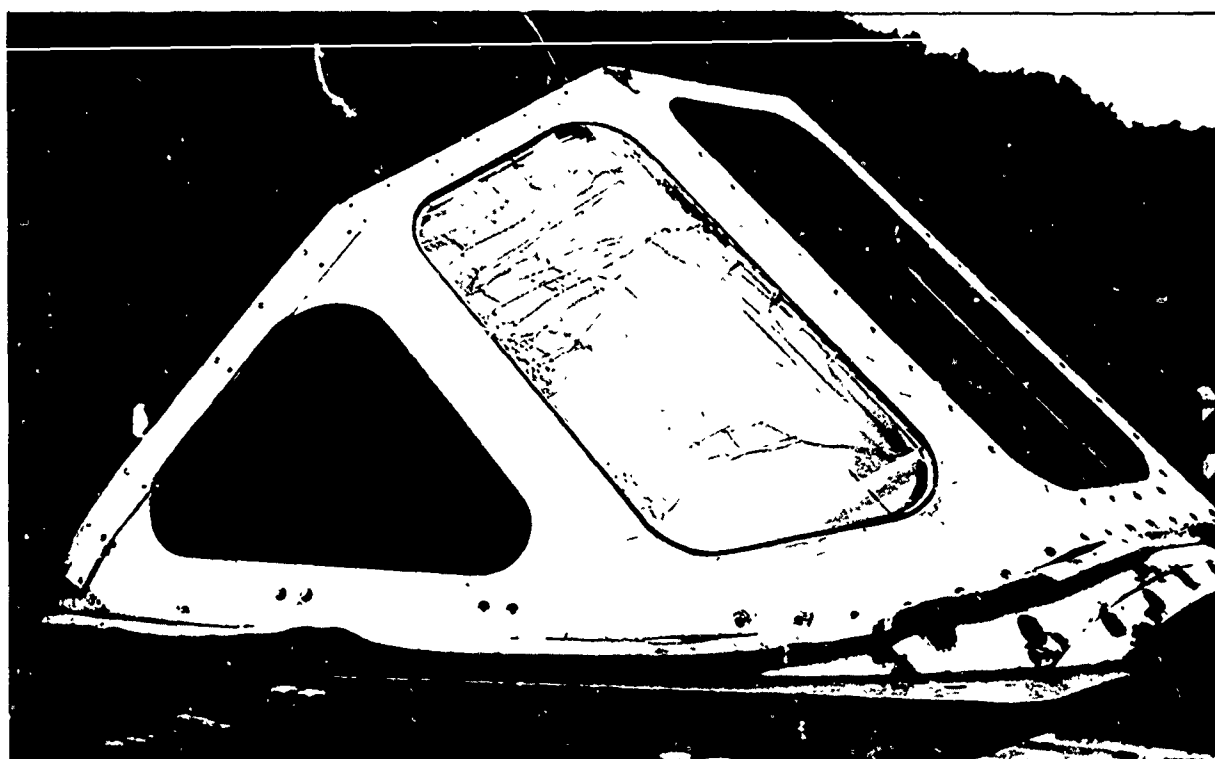
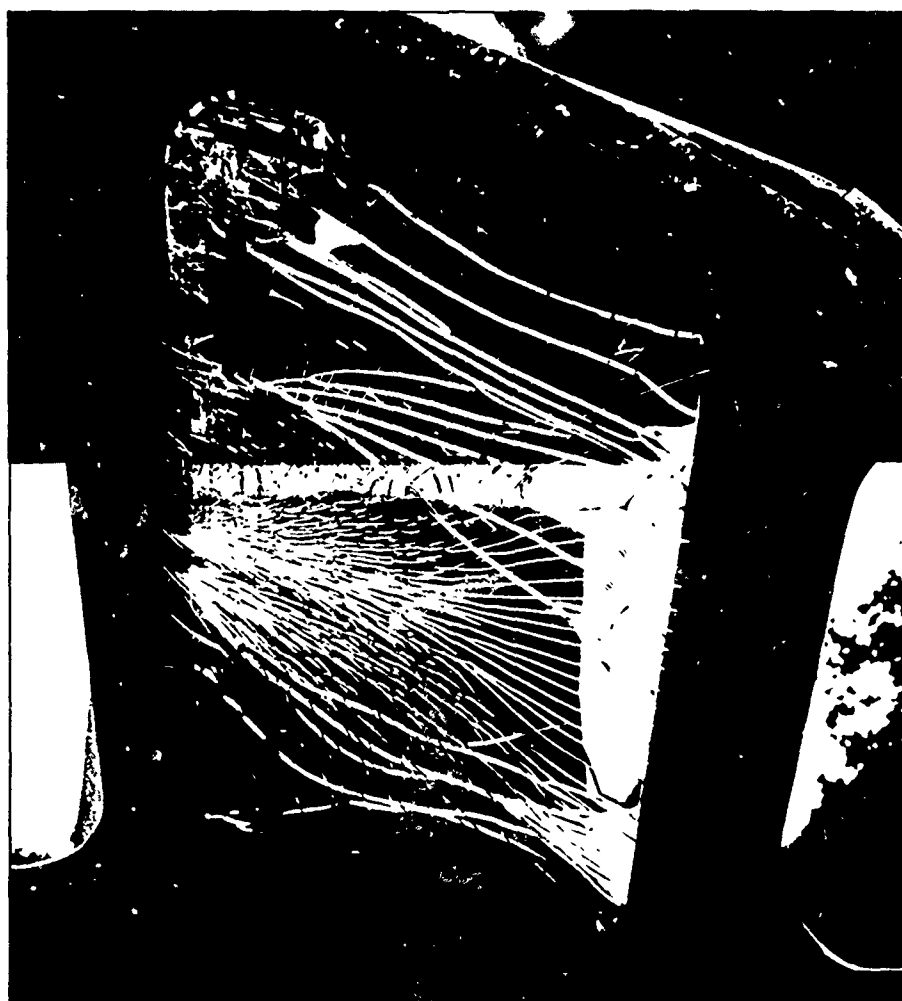
Impact of 2½lb bird at 285kt on heated (+50°C) side screen in OAT of -5°C

Fig.8 Typical of no penetration (Lower limit)

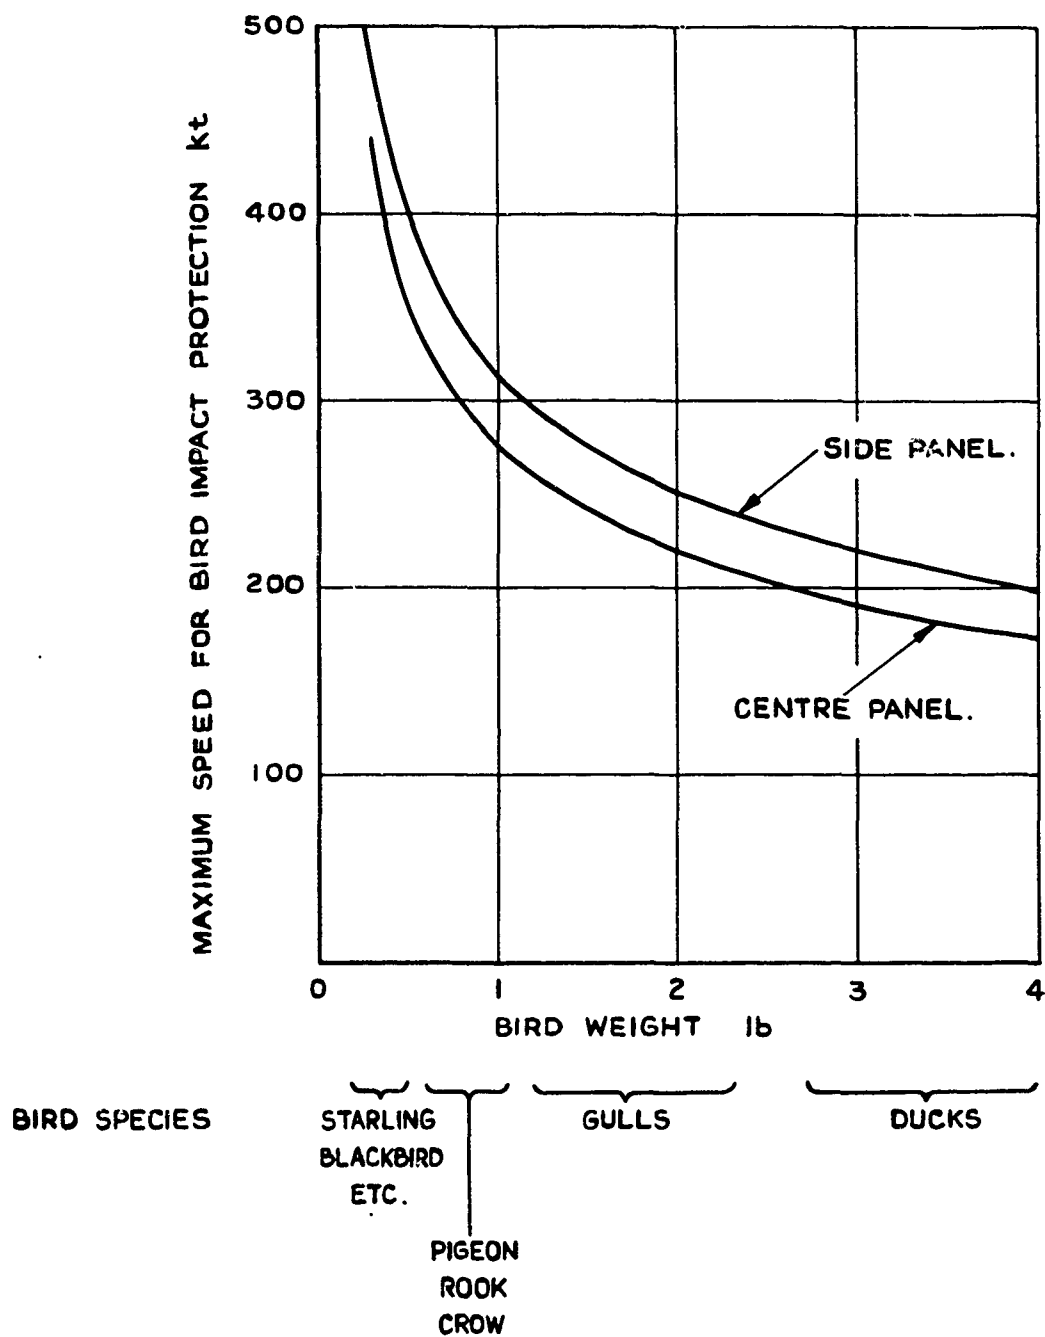
FIG. 9 BIRD IMPACT RESISTANCE OF VULCAN B MK 1
DRY AIR SANDWICH WINDSCREENS

performance and serious damage as defined in para. 4 above it has been assumed that the pilots personal equipment will protect him against the limited spalling which will occur. If the criterion is no spalling the limiting speeds would be some 30-50 kt lower than those indicated in Fig.9.

Since the toughened glass pane was inadequately supported and the P.V.B. layer inadequately clamped it is considered that the resistance of the screens would not be increased from the estimated values under conditions simulating warm outside air (15 to 25°C) and Fig.9 can be assumed to apply under all low altitude flying conditions.

6.1 The degree of protection against bird impact damage provided for the pilots of Vulcan aircraft by the main windscreen panels was determined and is shown in Figs.9 and 10. For the screens directly ahead of the pilots the maximum speed in knots for which protection is provided is

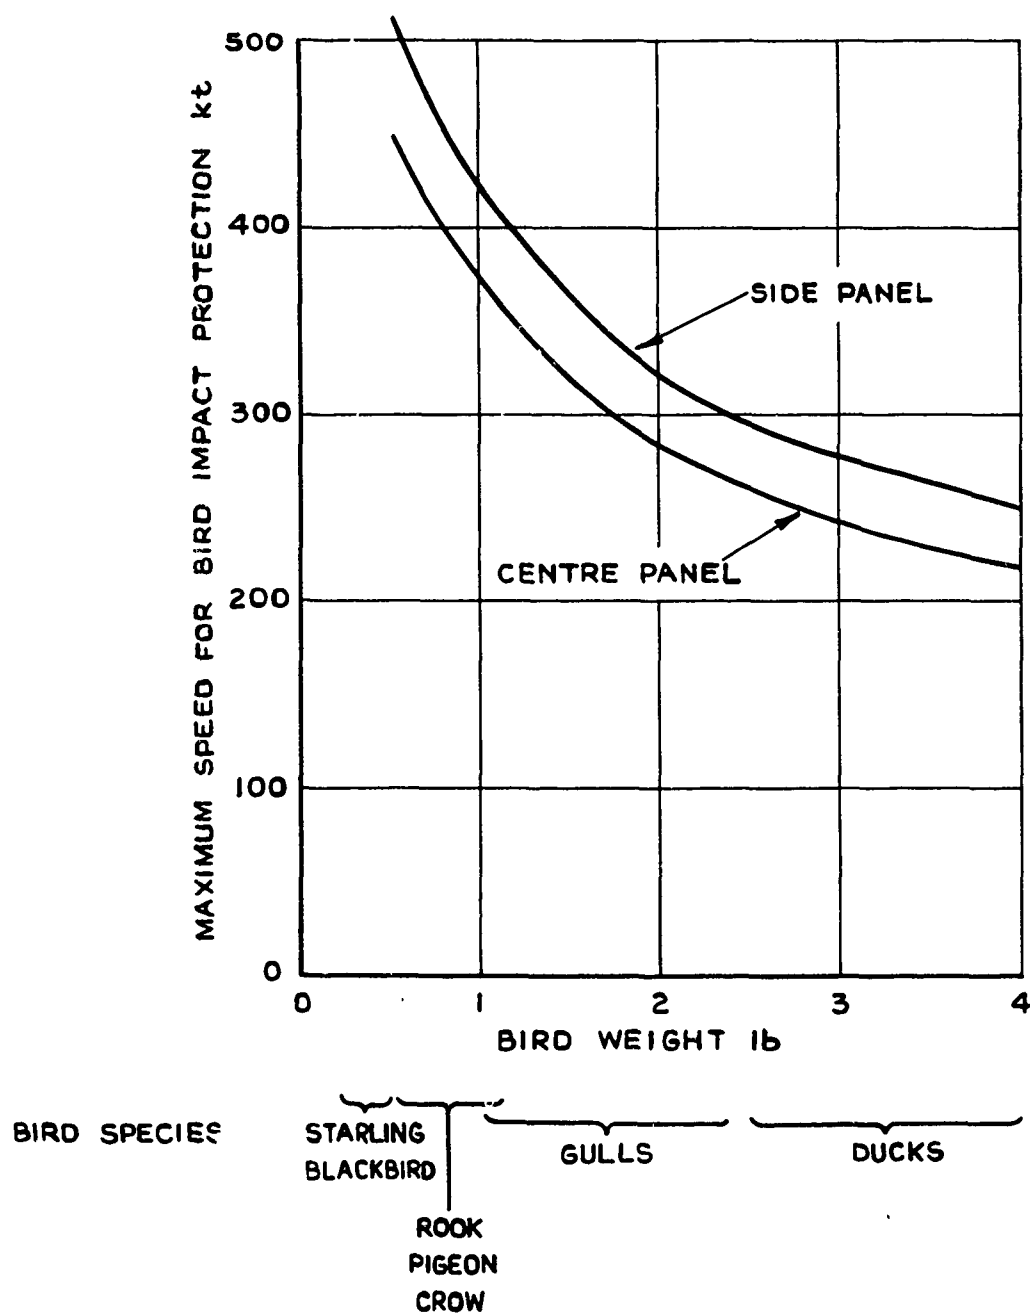
Fig.10

FIG. 10 BIRD IMPACT RESISTANCE OF VULCAN B MK 2
GOLD FILM WINDSCREENS

Test 10 indicated that the panel provided superior impact resistance for impact below the centre than for impact at the centre. It is considered that impact near the top or near the outboard edge would be more severe than impact at the centre. The speed values quoted in Figs.9 and 10 are therefore approximate values only.
